AFWAL-YR-88-4047

19. ABSTRACT (Continue on reverse if necessary and identify by block number) This program sought basic information about the behavior of coated superalloys versus strain-temperature history in high-temperature, thermal-mechanical exposure. The test plan was based on the observation that test cycle shape strongly impacts the thermal-mechanical-fatigue (TMF) behavior. We found that increasing T_{max} of the Type 1 cycle from 1900 to 2100°F shortened the initiation period for TMF cracking and reduced cycles to specimen failure by about 30 to 50 percent. A more radical change in cycle shape, namely a four-sided shaped cycle, was less mechanically damaging (a factor of two) but more severely oxidizing than Type 1 cycles between the same temperature and strain limits. Cyclic speed experiments showed that crack initiation and cycles-to-failure data were not strongly sensitive to testing speed in the range of 1 to 4 cycles per minute. Lower N_f values for slow speed tests are believed to reflect crack growth in the substrate rather than coating effects. Shut-down steps and hold times at T_{max} and during cool-down from T_{max} generally decreased N_f values.

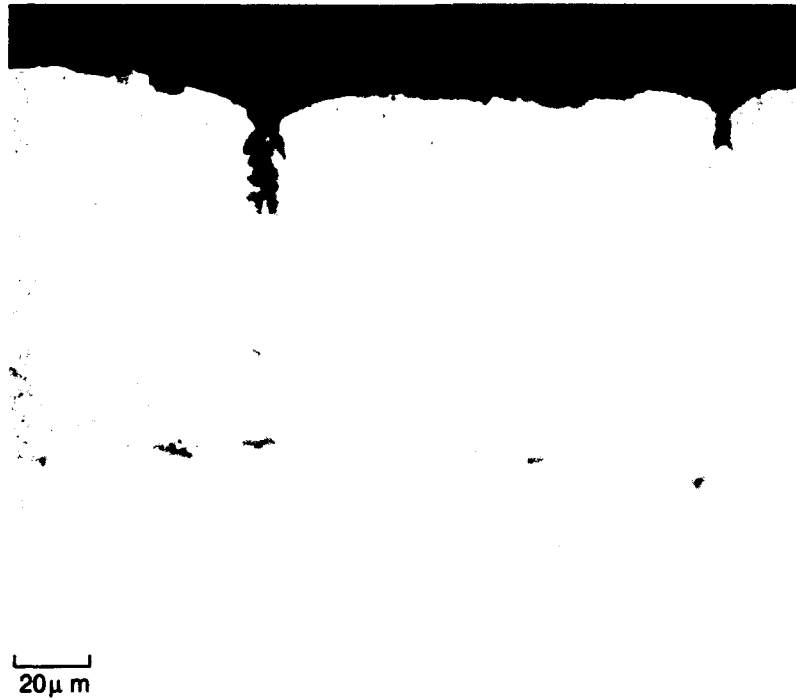
FD 357888

Figure 13. TMF Cracks in LPPS NiCoCrAlY After 1000 Cycles

For LPPS NiCoCrAlY (PWA 276) of the same nominal composition, no cracks were detected by binocular microscope, SEM, or metallography after 500 cycles. At 1000 cycles, cracking was discernable by careful binocular microscope examination, although the cracks were not nearly as evident as those on EB-PVD NiCoCrAlY after the same cyclic exposure. Again the cracks appeared relatively wide in polished cross sections (Figure 13), but none were observed to penetrate the coating. Scanning microscopy of the crack tip suggested a tendency to follow grain boundaries and $\gamma - \beta$ interfaces (Figure 14).

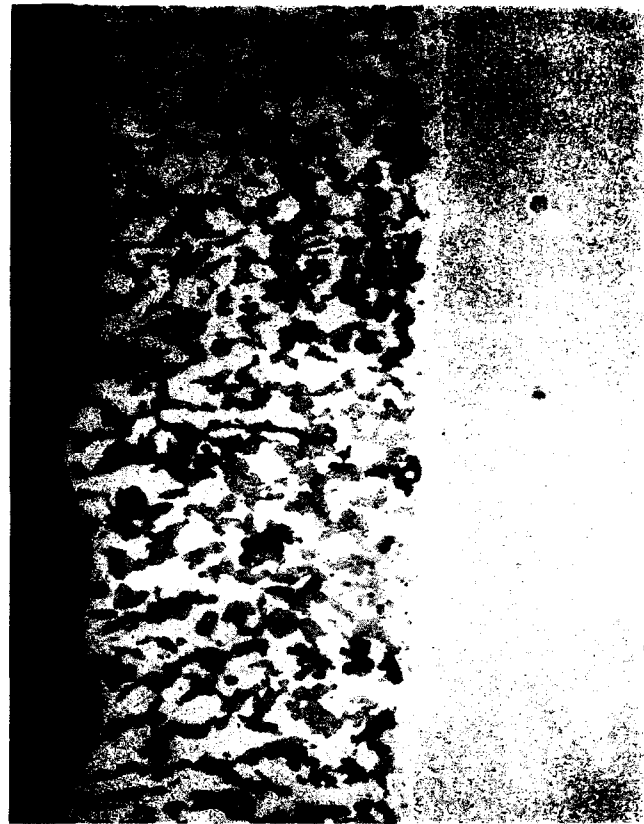
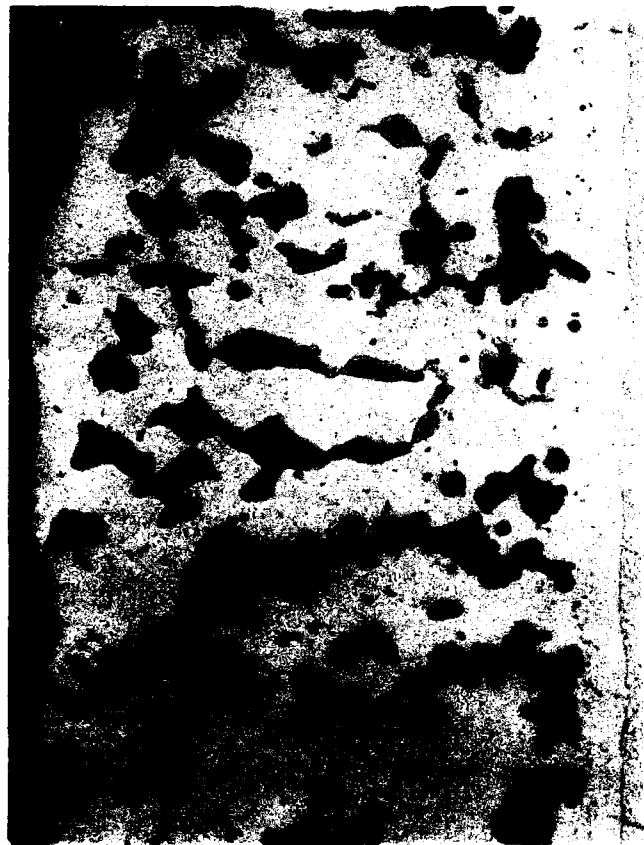
FD 357810

Figure 38. Microstructures of LPPS NiCoCrAlY After 12,842 Quad TMF Cycles

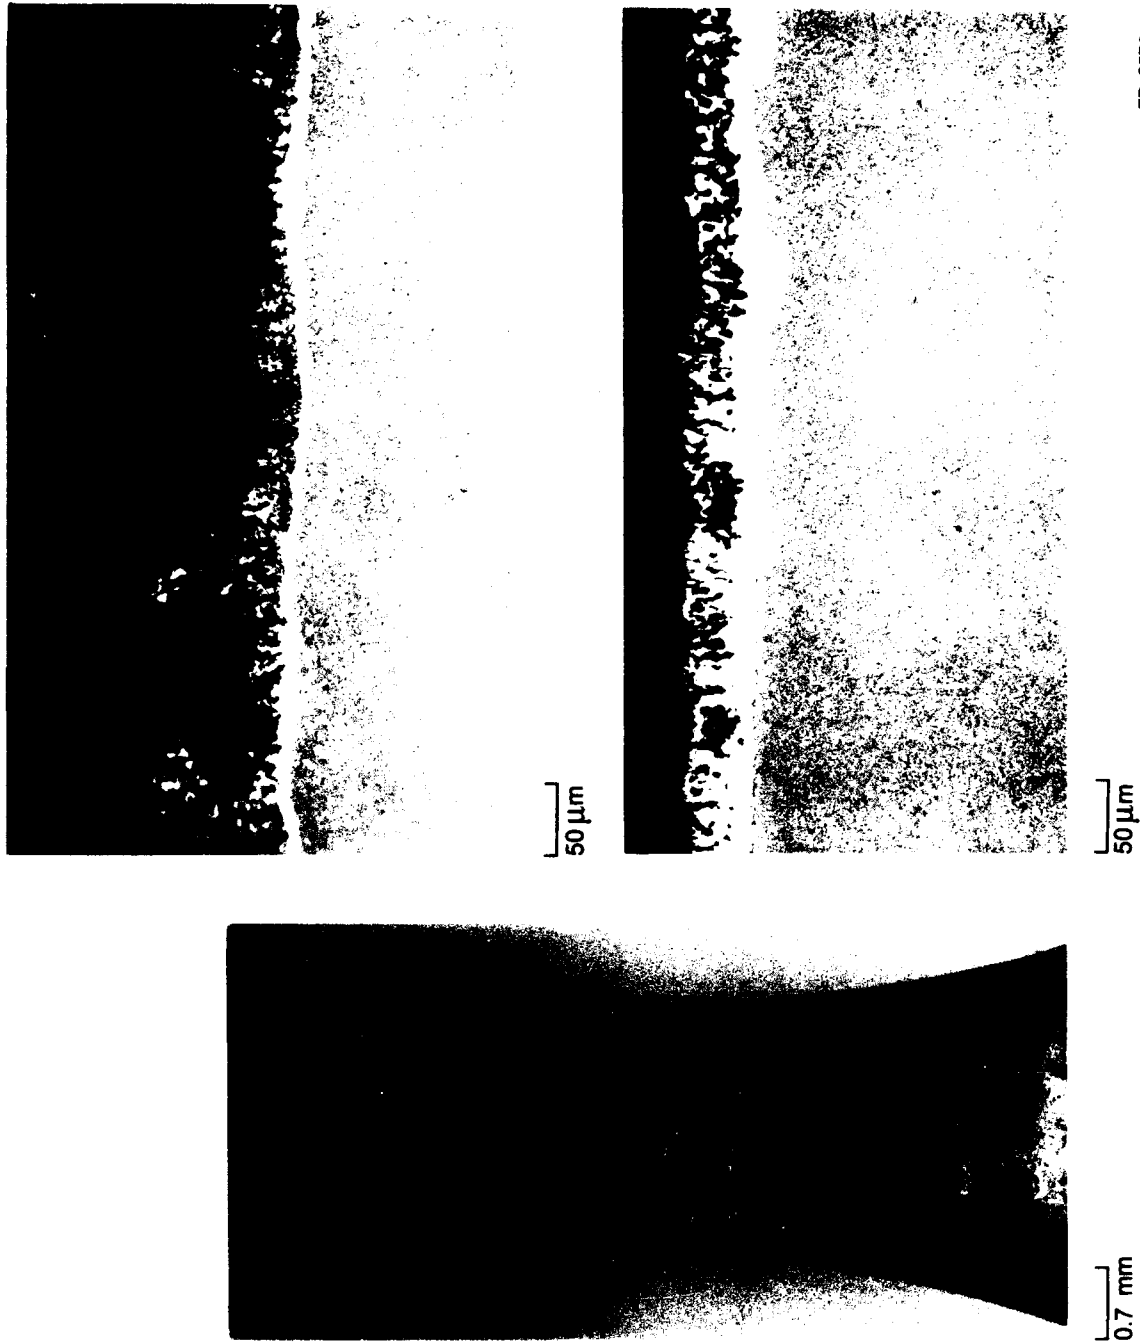
Figure 39. Quad Cycle TMF Sample of PWA 275 Gas Phase Aluminide on PWA 1480 (Cycle as in Figures 36 and 37, Exposure Time = 7455 Cycles)

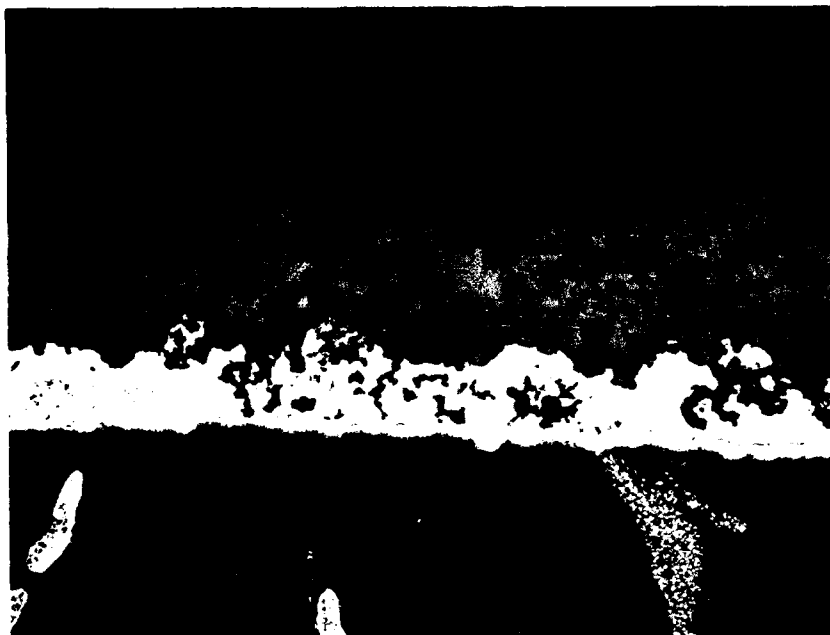
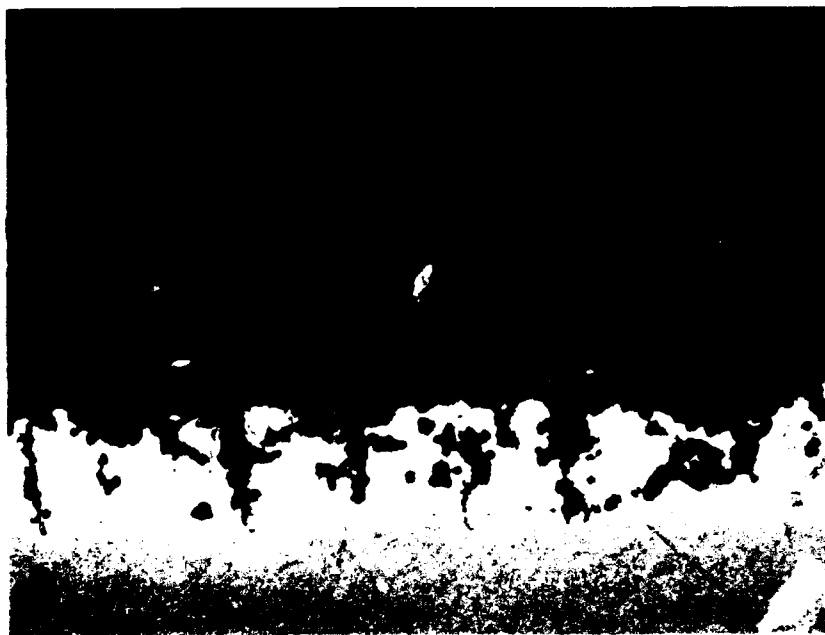
Figure 47. Bond Coat Oxidation in JTDE 2nd-Stage Vane After 4235 TAC's

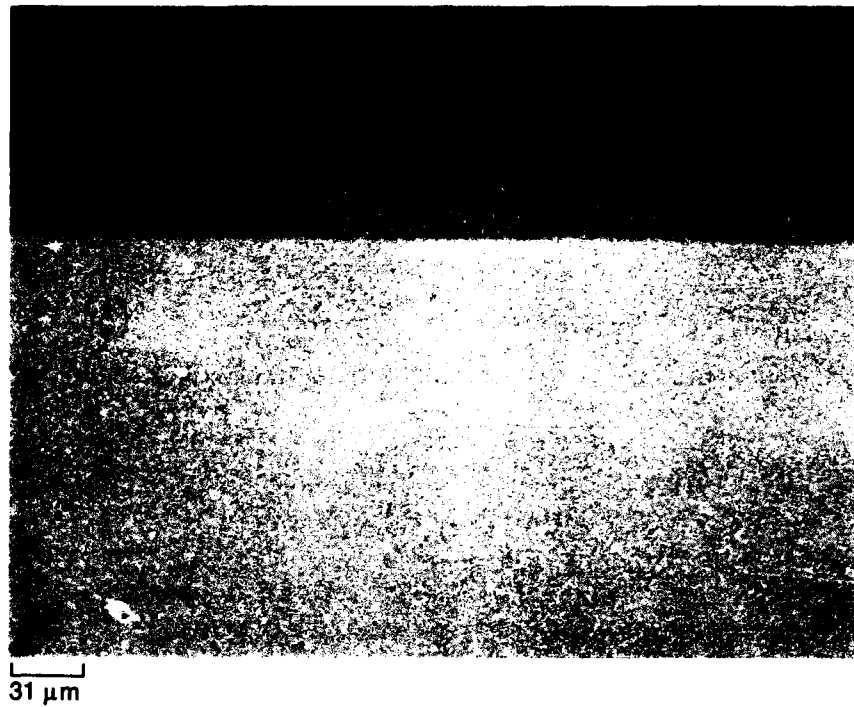
FD 357830

Figure 69. Hot Section Microstructure of Quad Cycle/Shutdown TMF Specimen of PWA 1480/PWA 275 Aluminide (Exposure Time = 4000 Cycles)
